NASA/TM-2004-213231/Version 0.01
NESC-RP-04-01/03-001-E

Cloud-Aerosol LIDAR and Infrared Pathfinder Satellite Observation (CALIPSO) Spacecraft

Independent Technical Assessment

ITA #: NESC-RP-001	
Requestor Name: William F. Townsend NASA Goddard Space Flight Center (GSFC) Deputy Director	Requestor Contact Info: (301)-286-5066 william.f.townsend@nasa.gov Code 100
Short Title: CALIPSO Spacecraft Proteus Propulsion System Assessment	
Description: Personnel hazards associated with Proteus Hydrazine propulsion bus once loaded (launch-36 days)	
Date Received: 10-22-03	Date ITA/I Initiated: 11-06-03
NESC Chief Engineer (NCE) Assigned: Michael Hagopian	NCE Contact Info: 301-286-6732
Lead Assigned: Dr. Richard J. Gilbrech	Lead Contact Info: 757-864-3303
Date ITA/I Concluded: 1-27-04

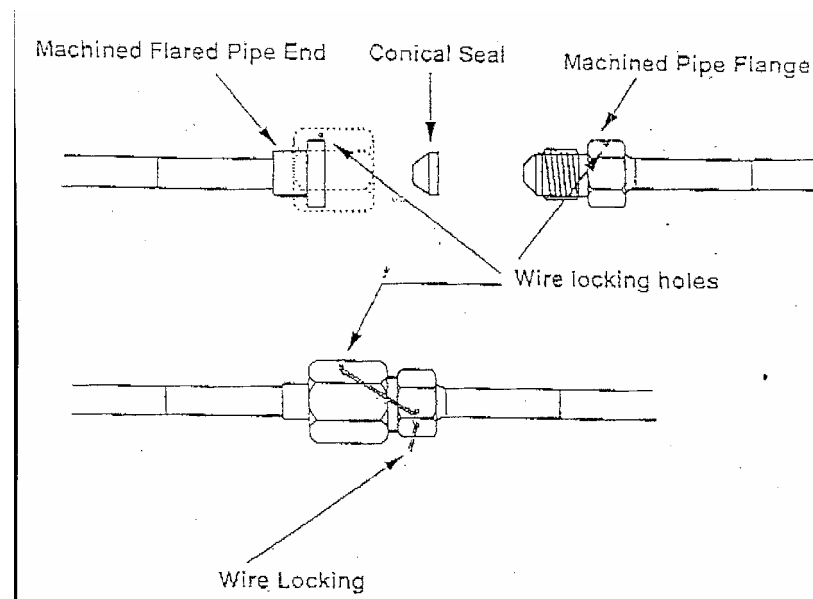
Figure 2. MS 33656 A/N fitting installation detail

Properly welded fluid connections are inherently more reliable than mechanical fittings and should be incorporated in fluid propulsion system designs when possible. There are some circumstances, however, under which mechanical fittings offer an appropriate design solution. Ready interface to off-the-shelf parts, ease of maintenance, or potential for damage to soft goods during welding all may dictate use of threaded joints. MS-33656 type 37° A/N-fittings have been employed successfully in aerospace applications for many years and are acceptable for limited use providing they are (1) properly assembled, (2) validated by leak check as an assembly before use, (3) exposed only to temperature, pressure, vibration and shock environments for which they are certified, and (4) incorporate a secondary locking feature. The Proteus bus uses five such fittings; one at the hydrazine tank outlet and one at each of the thruster inlets (see Figures 2 and 3 for details). While lock-wire is used as a secondary locking feature, it is suitable only for preventing significant rotation of the B-nut and full disengagement of the fitting. Lock-wire alone will not prevent loss of joint preload⁸ with subsequent reduction of clamping force at the sealing surfaces, and thus cannot be counted upon to prevent a fitting from leaking.

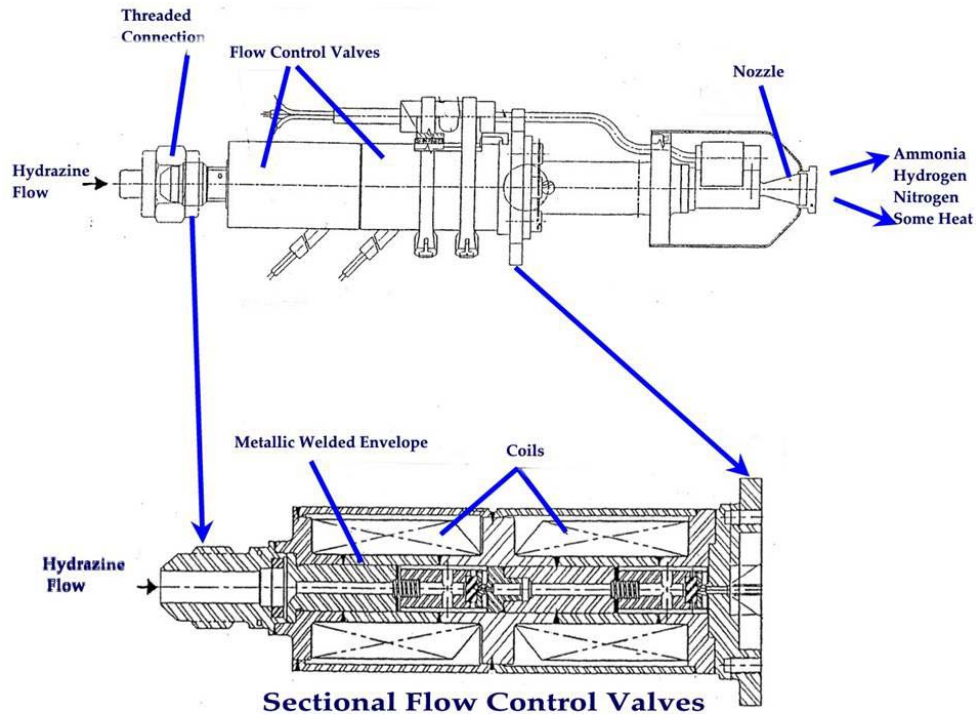
Figure 4. Moog Dual Seat Dual Servo Thruster Valve

NESC concludes the potential for external leakage from the thrusters either internally (across the control valves) or externally (thruster casing or seal) poses acceptable risk to personnel providing the program conducts an adequate pre-servicing leak check of each valve. While the program did indicate such testing was planned, NESC was not provided a specific description of the test or its pass/fail criteria.

NESC-R-007 – Program shall demonstrate that pre-servicing thruster leak checks will be adequate to validate system integrity. Leak check procedures shall test each valve independently and shall specify test method, equipment to be used, media, test pressure and allowable leak rate.

NESC-R-008 Program shall verify that the Proteus Moog valves on CALIPSO do not have defective plunger assemblies.

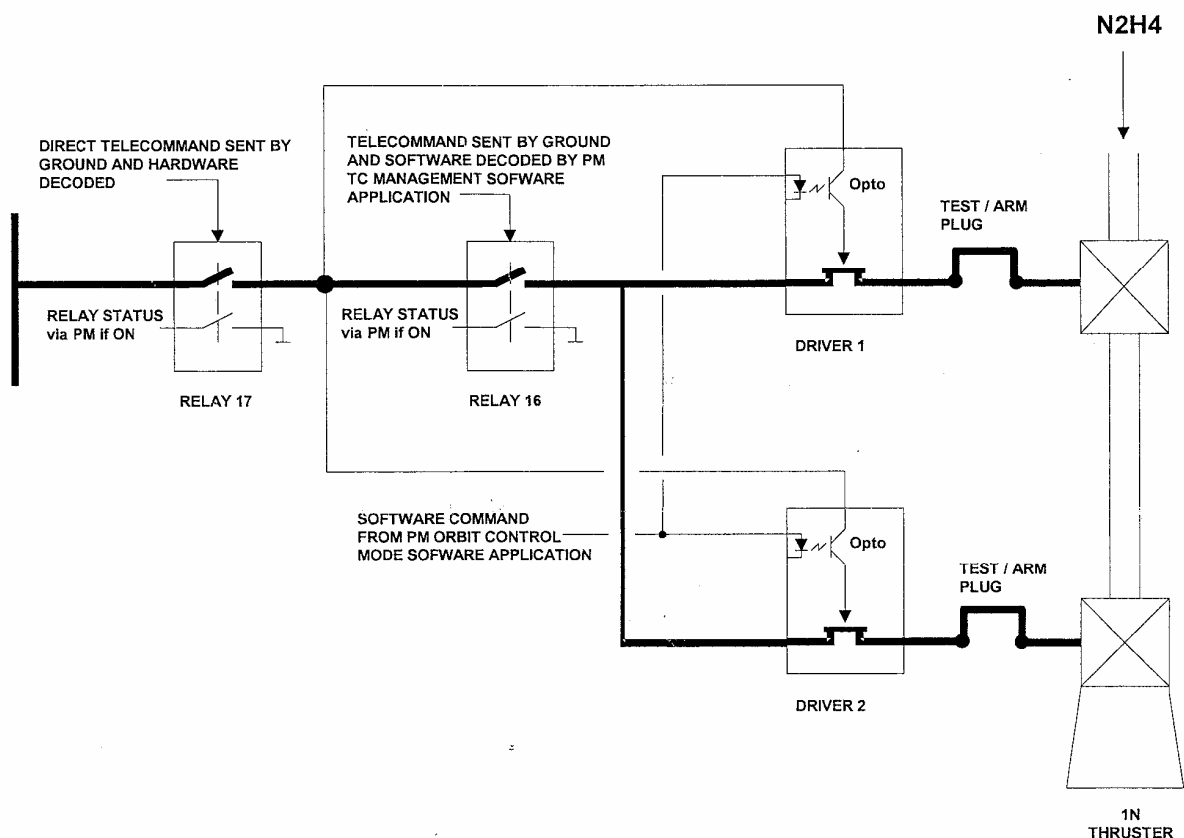
**Figure 5. Thruster Circuit Schematic with New Test/Arm Plugs
(PM refers to spacecraft processor module)**

The Proteus thruster firing circuit incorporates a number of controls to ensure valves are not inadvertently opened causing a thruster to fire. NESC concurs the controls are adequate, but recommends further steps be taken to positively preclude the possibility of an inadvertent command during periods of dynamic testing, especially power-up. A schematic of the thruster wiring circuit is shown in Figure 5. It is worth noting that the Astrium specification sheet for the thruster lists nominal flow rate at 0.44 grams per second. Even with all four (4) thrusters firing at nominal flow rate, it would take 4.7 hours to drain the 30 kilograms of hydrazine in the propellant tank.
